MINUTES FROM CONFERENCE CALL TO DISCUSS INVESTIGATION AND REMEDY
OPTIONS AT TANK FARMS 1, 2 AND 3 AT DEFENSE FUEL SUPPLY POINT NS NEWPORT
RI
4/9/2009
TETRA TECH EC

**DFSP MELVILLE CONFERENCE CALL
MEETING MINUTES
April 9, 2009 11:00 – 13:30**

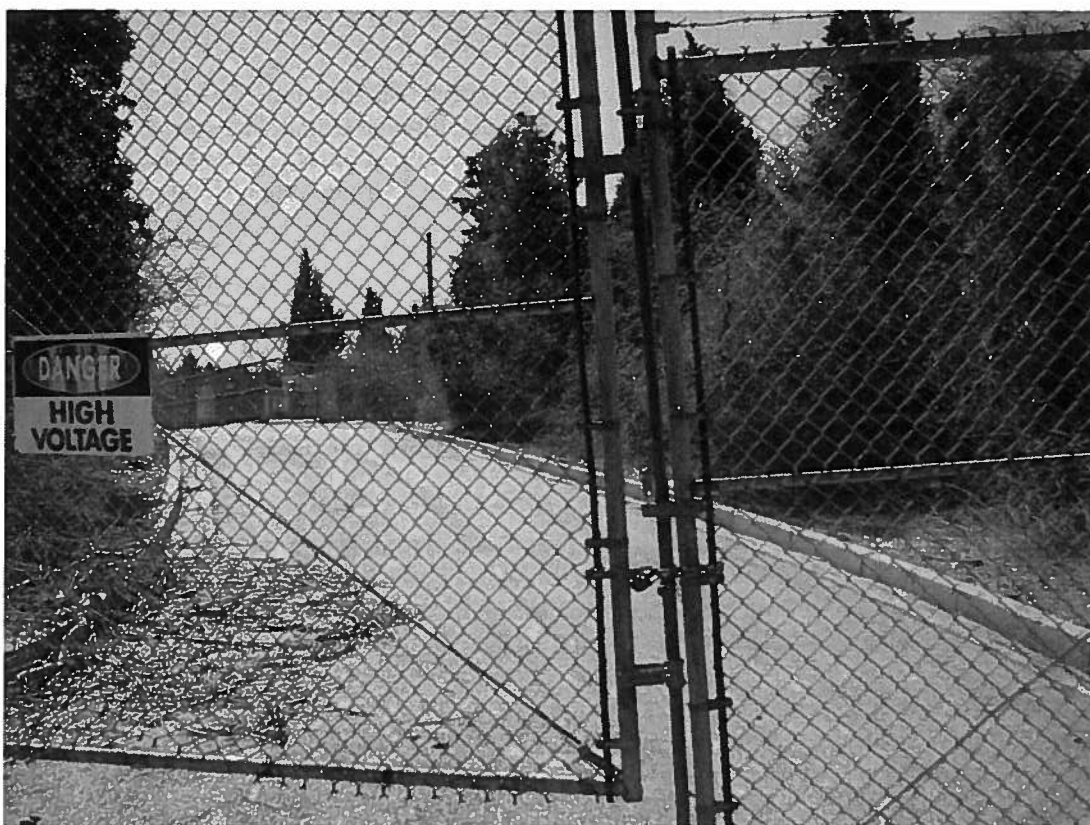
- Building 230 – based on drawings, this building is believed to be the active transformer at the entrance to Tank Farm 3.
On 4/16/09, a site walk of the Building 230 area was conducted by Richard Claydon as a courtesy to the Navy. Observations determined that this building is outside of the Tank Farm 3 fence line. Posted signs indicate this is Substation 12 (see Photograph 1).

Photograph 1: Building 230 entrance (outside of Tank Farm 3 fence line) 4/16/09

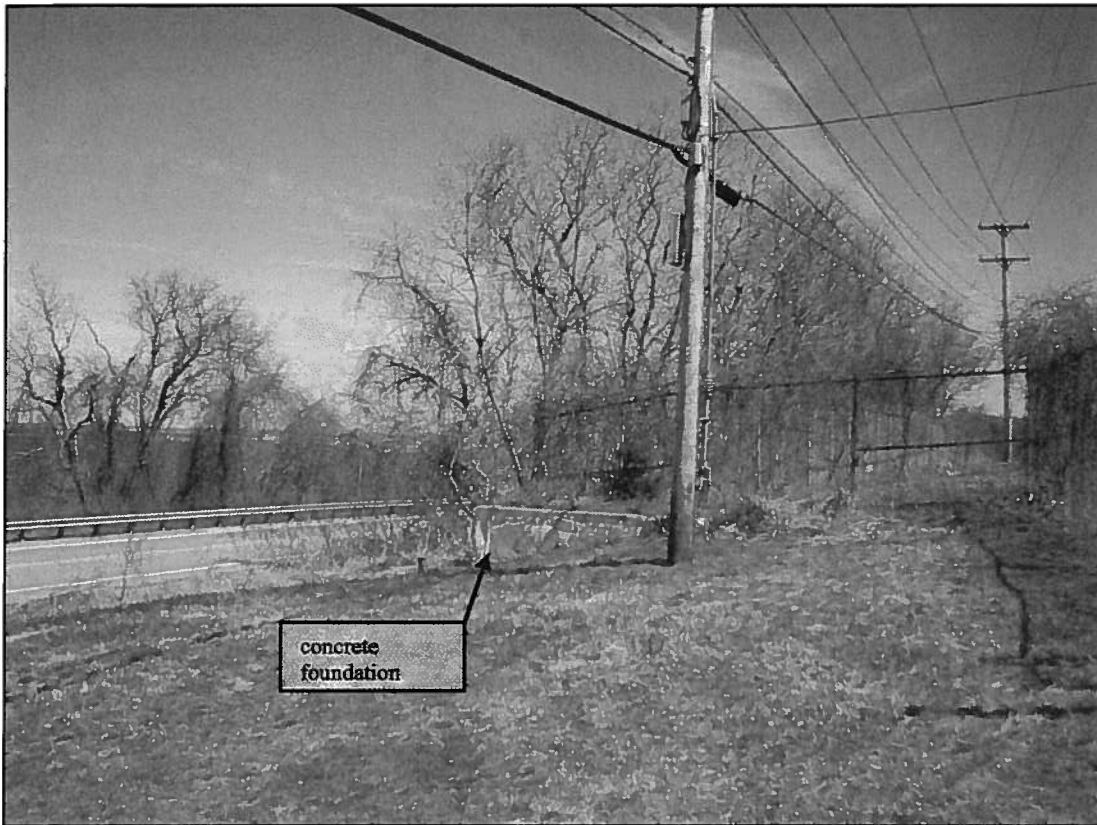
- Building 108 – based on drawings, this building is believed to be the valve house along the east side of Defense Highway and on the south side of Lawton Brook near the Tank Farm 3 entrance. On 4/16/09, a site walk of the Building 108 area was conducted by Richard Claydon as a courtesy to the Navy. Observations determined that this building is outside of the Tank Farm 3 fence line. Only a concrete foundation remains. It appears Building 108 is not a valve house but rather a former transformer location (see Photograph 2).

Photograph 2: Building 108 Area (outside of Tank Farm 3 fence line) 4/16/09
